# ROCKY MOUNTAIN NATIONAL PARK ROADS

ROCKY MOUNTAIN NATIONAL PARK ROADS - 1920/1932

SHEET 6 OF 8

HISTORIC AMERICAN  
ENGINEERING RECORD  
CO-78

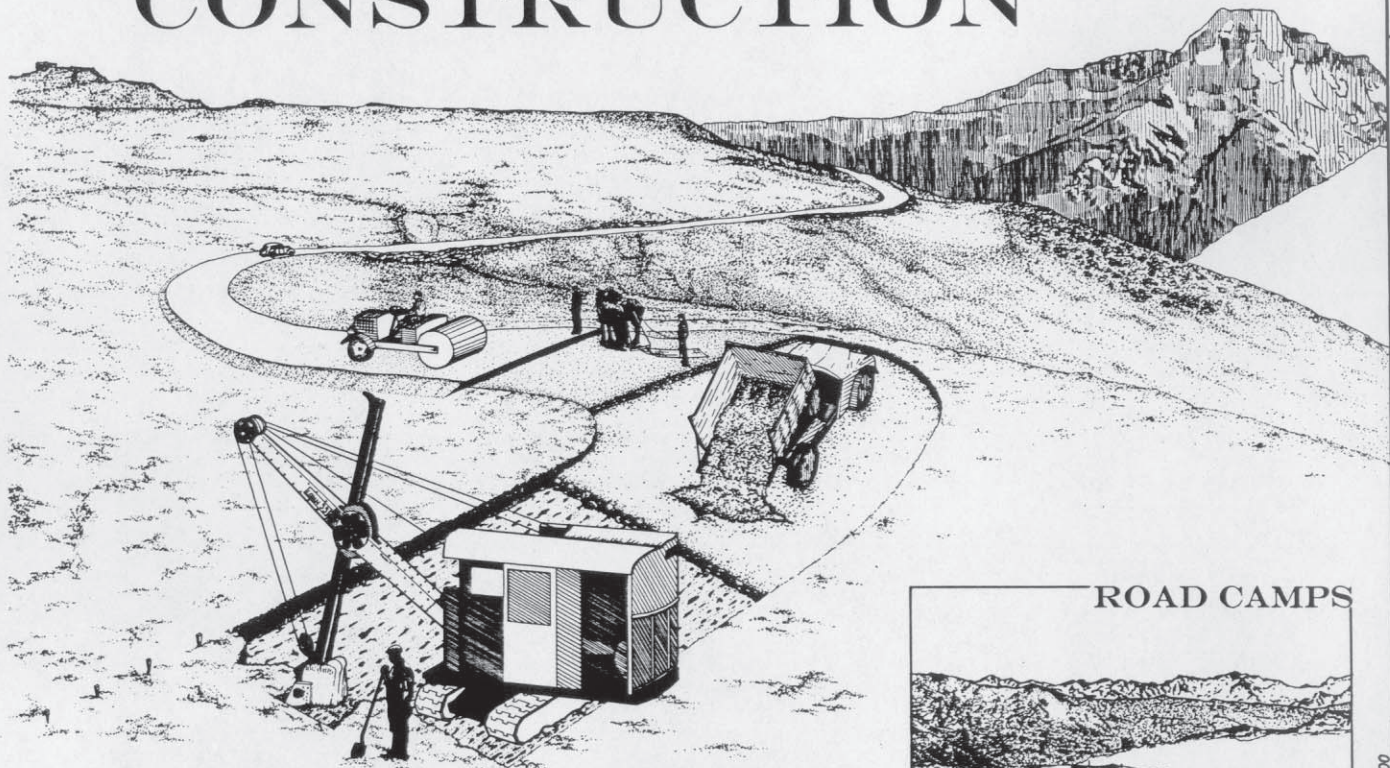
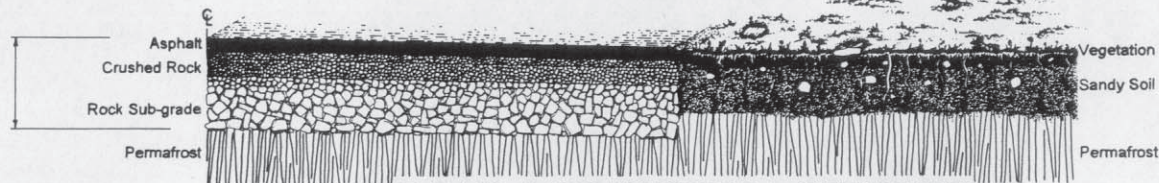
ROAD AND TUNDRA SECTION

One of the greatest challenges was constructing the roadway across the alpine tundra and permafrost, an extremely delicate ecosystem that develops at a rate of about an inch every hundred years. Normal drills would not penetrate the frozen material, and special equipment had to be designed. The thinner areas could be stripped away like sod or melted by exposure, but where it was deep, disturbance had to be minimized. The deeper parts below the surface could not be allowed to melt, or the area would turn into a permanent quagmire. Here the upper sections were carefully removed, then a prepared roadbed was constructed on rock fill resting directly atop the frozen soil. The tundra sod that had been salvaged was then used to cover the roadbanks scarred during construction.

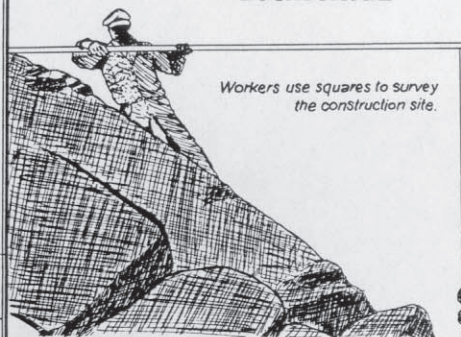
Workers use squares to survey the construction site.

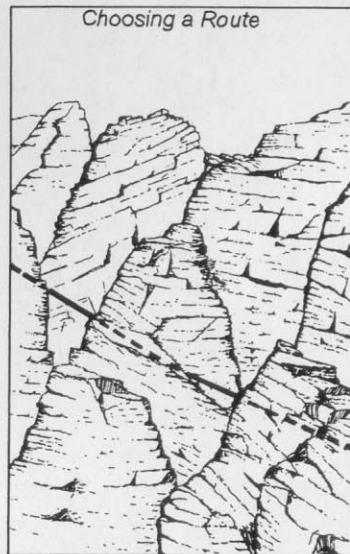
Choosing a Route

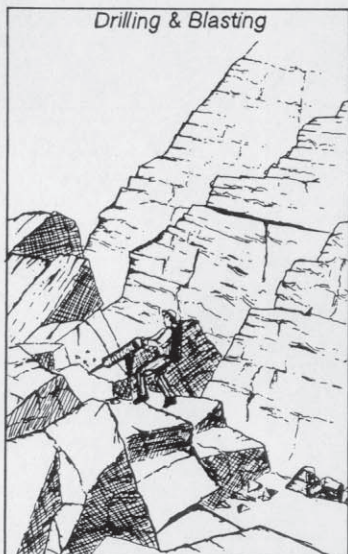
Drilling & Blasting

This projecting rock formation at 12,110' elevation had to be cut through by road crews in order to allow the Trail Ridge Road to pass. The highly resistant rock was blasted away with large quantities of explosives, in one case, 178 shots (a half ton of black powder) were wired together and fired at one time. The workers took special care to preserve the surviving stone monoliths on the downslope side, wrapping them in timber to protect them from rocks hurled by the blasting. Rocks thrown beyond the construction zone were retrieved to avoid marring the landscape. A steam shovel was employed to excavate the blasted material which was crushed and used in the bench sections for surfacing. The road through the rock cut is supported on high hand-placed dry-laid stone embankments topped by crenellated parapet wall.

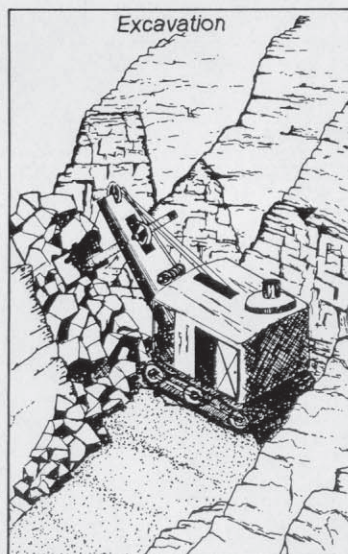
Excavation

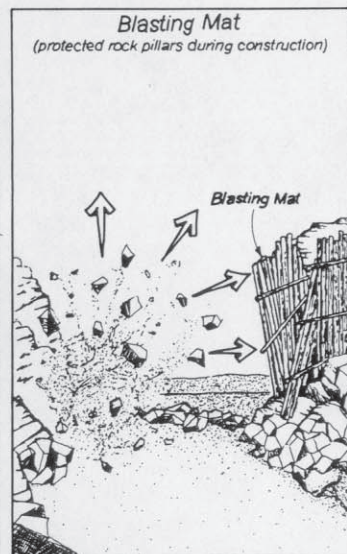
Blasting Mat  
(protected rock pillars during construction)

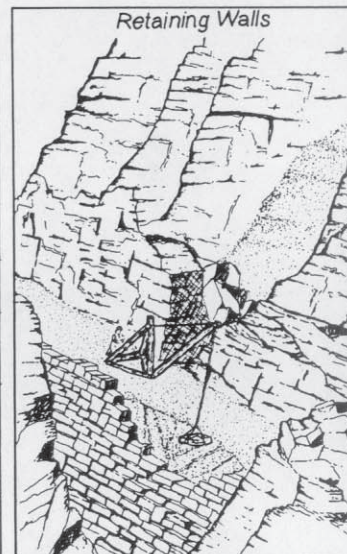
Retaining Walls

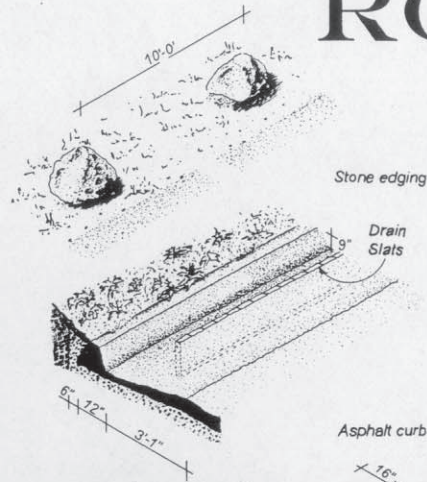
Stone edging

Drain Slats

A variety of roadside treatments were employed along the edge of the Trail Ridge Road. The hand-laid rustic-style stone walls are the most extensively used form of roadside barrier. The original walls were "Type 3" crenellated parapet walls constructed from native stone chosen to harmonize with roadside outcrops. Over the years, some of these walls were partially buried as the road was repaved. Some of these sections are now being replaced with concrete core walls faced with native stone, much of it salvaged from the older walls. The park also has installed segments of precast concrete walls faced in artificial stone. These are used to stabilize

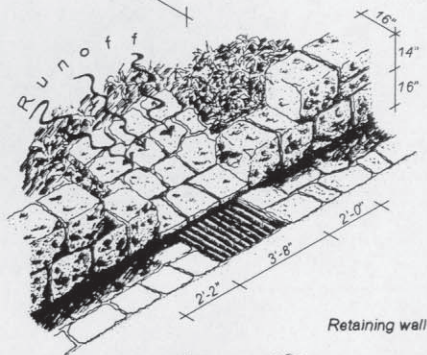
Retaining wall

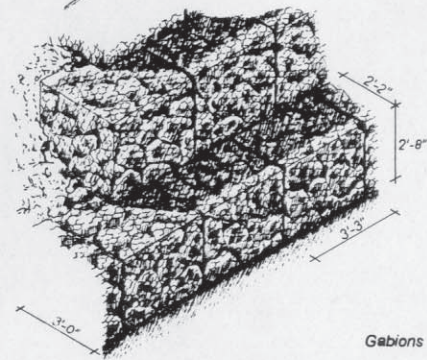
Gabions

roadsides and to prevent uphill slopes from eroding, reducing the money and labor spent in ditch clearing and boulder removal. Wood poles resting on small cross logs are generally employed to discourage parking on narrow road sections; asphalt curbs flank other sections. Heavier log rails set into vertical posts formed roadside parapets on older road segments. Light A-frame pole fences are employed to delineate a separation between the roads and the wilderness beyond. On steep unstable sections prone to slides, gabions, rock-filled wire baskets, were used to stabilize the slopes.

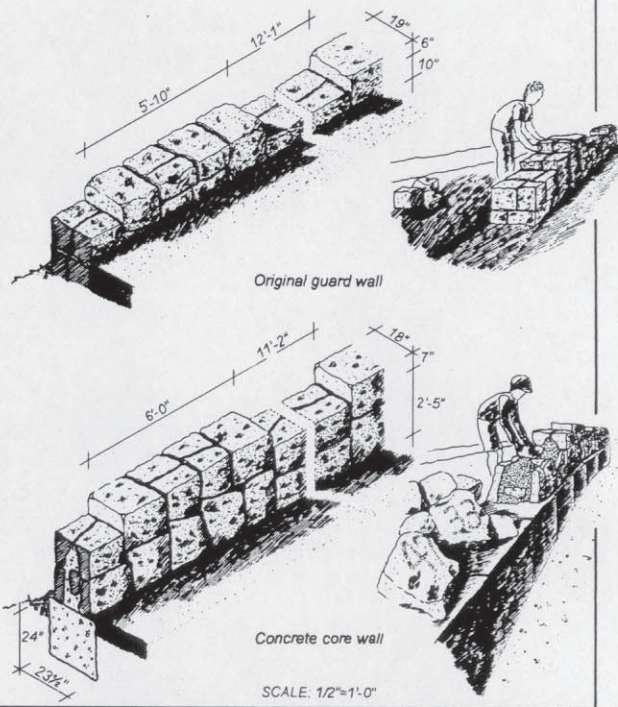
Replacement concrete core wall faced with native stone

Concrete core wall

## WALL RECONSTRUCTION

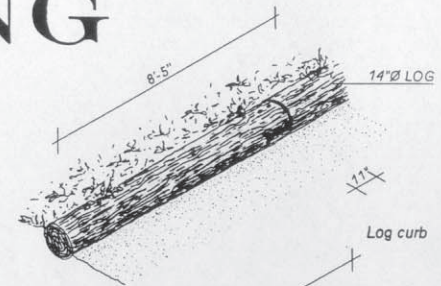
Log curb

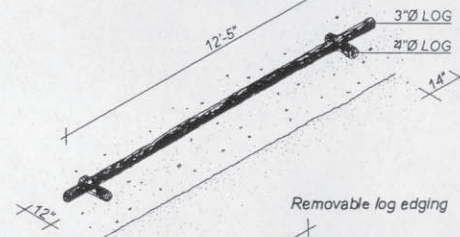
Removable log edging

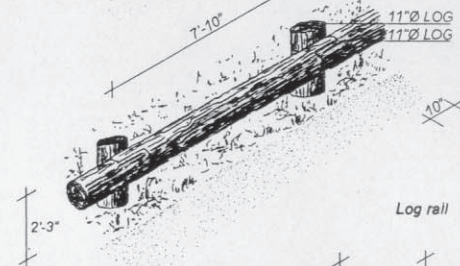
Log rail

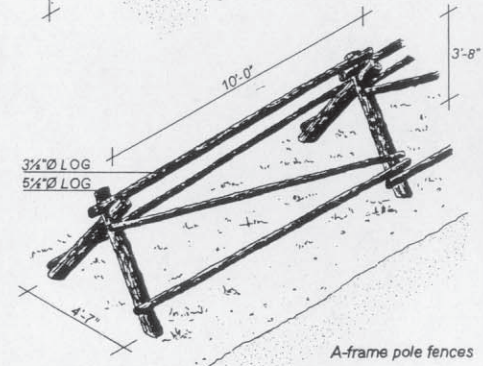
A-frame pole fences

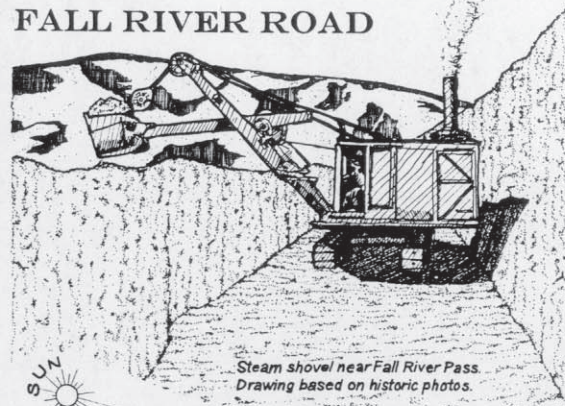
Steam shovel near Fall River Pass.  
Drawing based on historic photos.

Immediately after the Fall River Road was completed in 1920, park administrators realized that clearing snow would be a daunting task. The road climbed to Fall River Pass in a deep shaded valley, where avalanche chutes dumped deep accumulations of snow. The road was initially cleared with hand labor. Working conditions were severe. Cold temperatures combined with winds ranging up to more than 200 mph created extreme wind chill conditions. The high altitude sun caused snowblindness and severe sunburn. New avalanches would often cover cleared sections, forcing crews to repeat their work. Experiments were made with dynamiting and the use of blow torches, kerosene flares and carbide lamps, but it soon became clear that heavy equipment would be required. In 1925, the park acquired a specially designed steam shovel. In 1931 a "Sno-Go" rotary plow was placed in operation. Still, the tremendous snowpacks along the road were a major factor in deciding to construct the Trail Ridge Road on more open terrain. While the Trail Ridge Road was designed to pass through more open country with fewer places obstructed by heavy snow accumulation, the road climbed nearly a thousand feet higher than the Fall River Road and was also buried under deep snowpacks most years. By the time the road was completed in 1932, the park was using its new rotary plow. Even so, all old snow deeper than 45" had to be loosened with dynamite before it could be removed with machines. While heavier plows are now employed, opening the two park roads remains a tremendous and expensive undertaking. Despite periodic calls from tourist interests in nearby communities to keep the roads open year-round, crews face major challenges opening Trail Ridge Road by its target date of Memorial Day and Fall River Road by the Fourth of July.

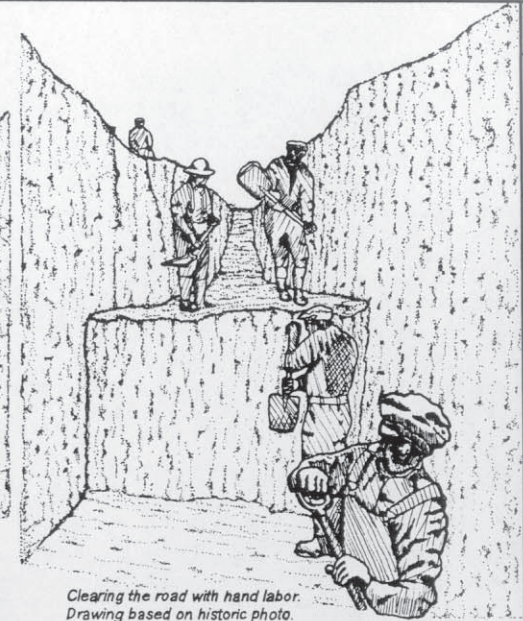
Clearing the road with hand labor.  
Drawing based on historic photo.

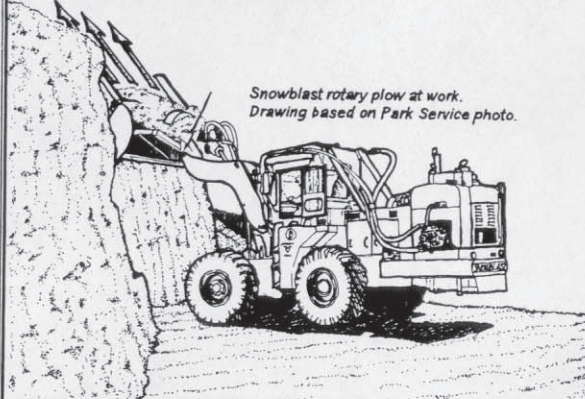
Snowblast rotary plow at work.  
Drawing based on Park Service photo.

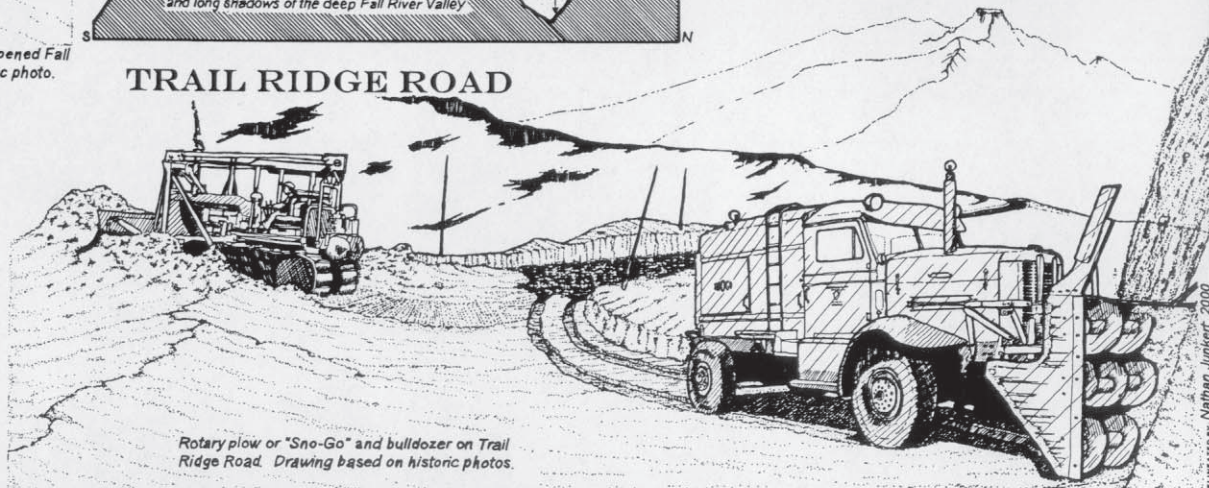
Rotary plow or "Sno-Go" and bulldozer on Trail Ridge Road. Drawing based on historic photos.
